Chapter 6.

Genus-Level Macroinvertebrate Community Descriptions

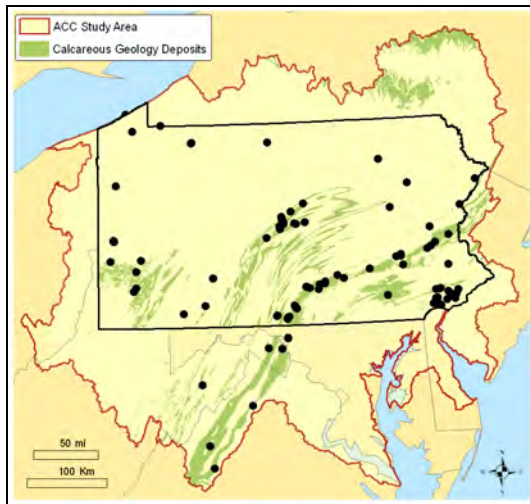
Figure 6-1. The locations of the Limestone / Agricultural Stream Community Locations are concentrated in areas of calcareous geology.

Habitat: The Limestone / Agricultural Stream community is found in calcareous (limestone and dolomite) valleys across the study area (Figure 6-1). This community type occurs most commonly in medium to large-sized streams ($\bar{X} = 62.3 \text{ mi}^2$ watershed area) at intermediate elevations ($\bar{X} = 217 \text{ m}$) and moderate gradients ($\bar{X} = 0.9\%$).

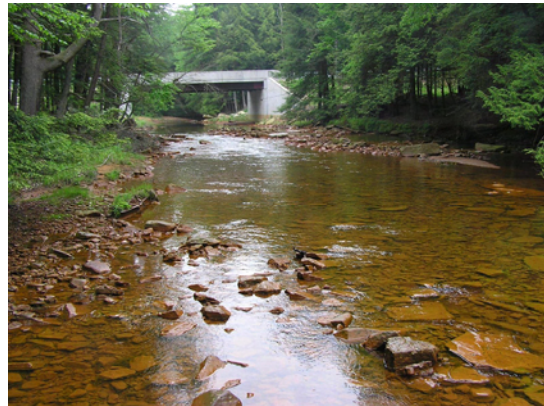
Toby Creek, Clarion County, PA
(Note reddish color of stream bottom,
an indicator of AMD)
